Frontal dune 'notching' in the United Kingdom

Some personal experiences and opinions

Professor Kenneth Pye ScD PhD MA FGS
Kenneth Pye Associates Ltd.

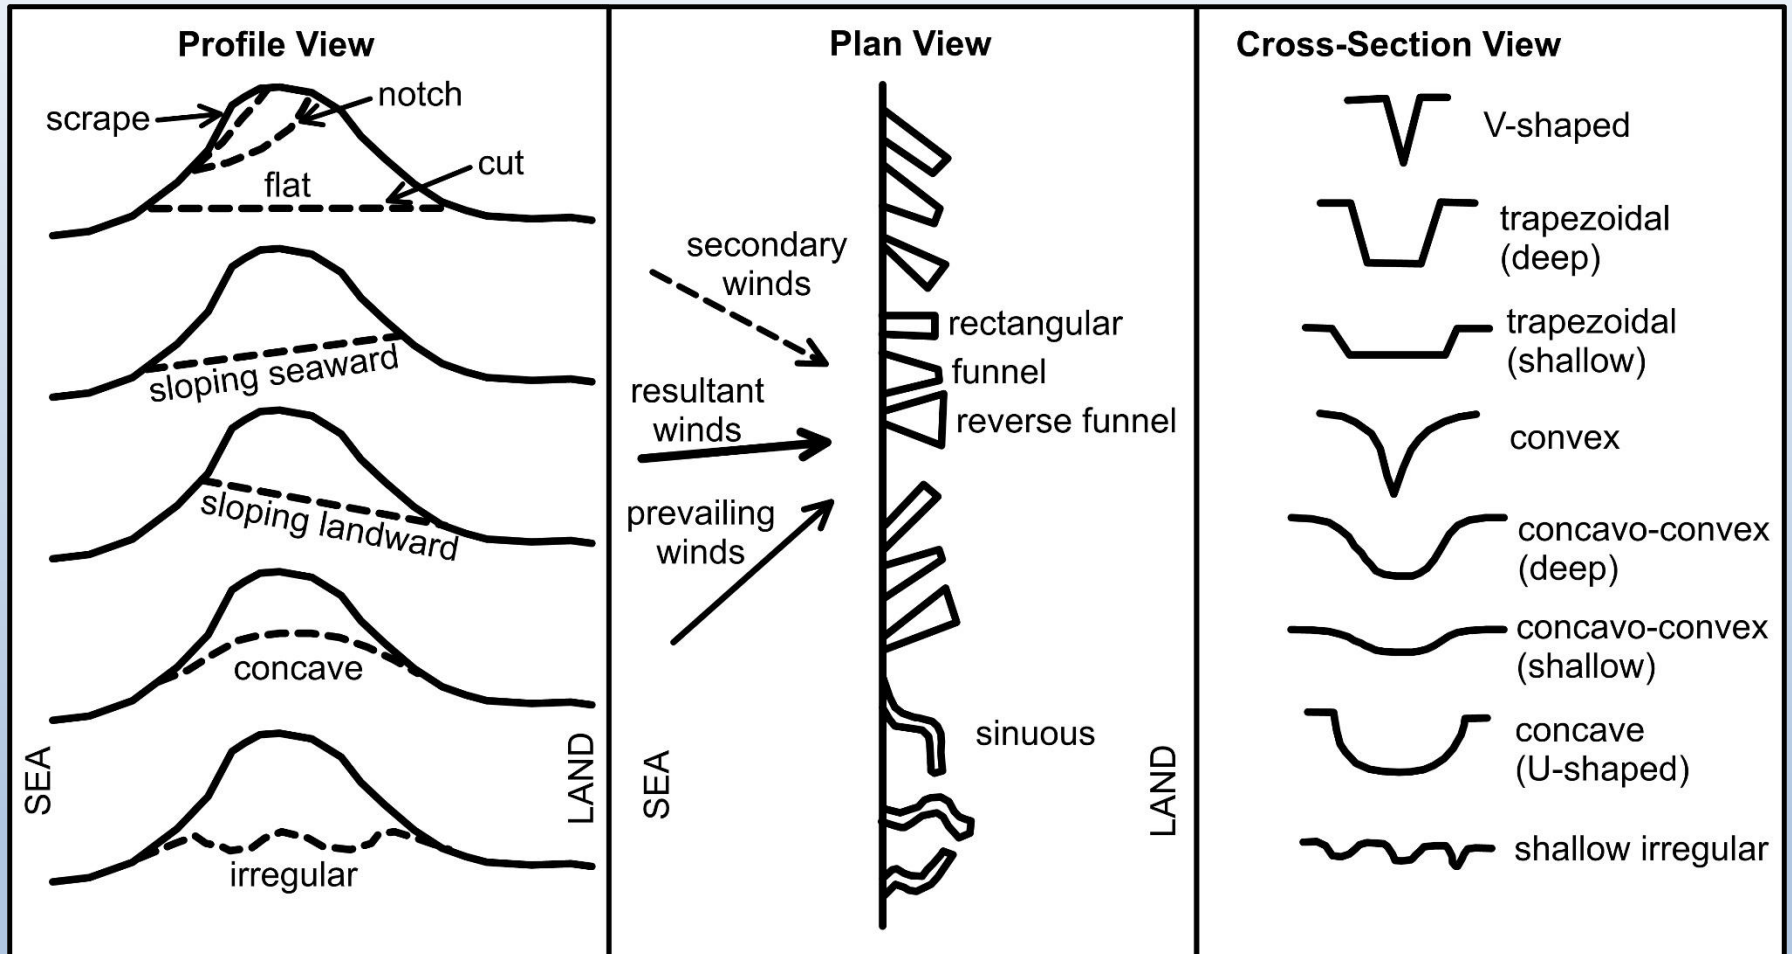
Options for Scrape, Notch and Cut Design

- Scrape – a shallow depression / bowl / basin
- Notch *sensu stricto* – a deeper, often elongated excavation of limited depth which does not pass through the entire width of a dune – simulates a natural blowout
- Cut – an elongated excavation which passes through the entire width of a dune and which may vary in depth from shallow to the entire height of the dune

Scrapes, notches and cuts involve movement of increasing volumes of sand and increasing cost

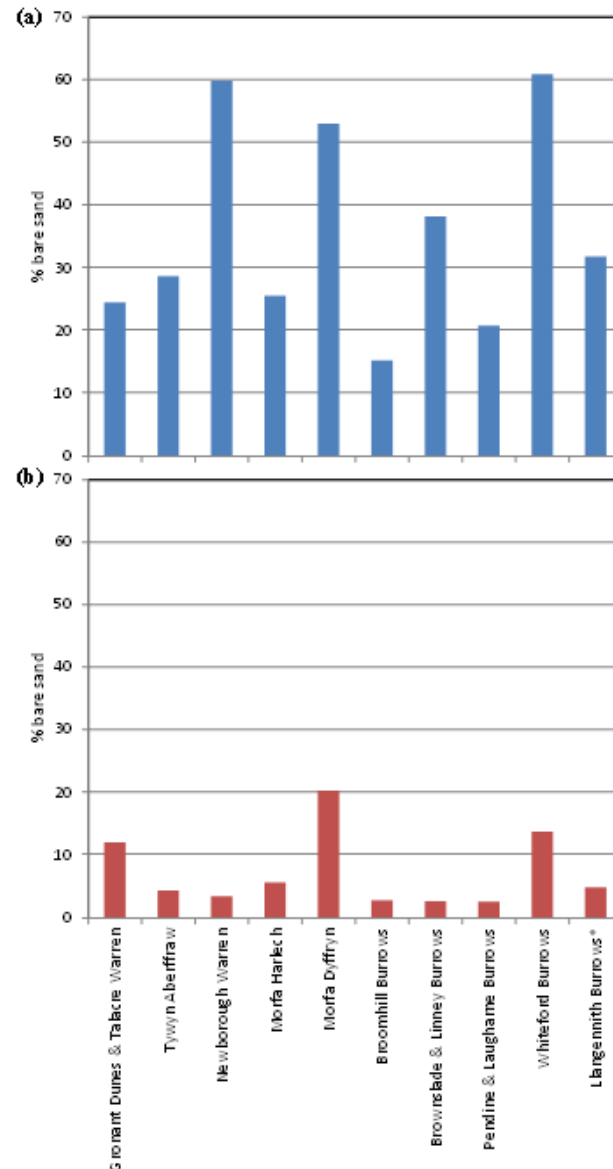
Change in percentage area of bare sand within Welsh SAC dune systems between the (a) 1940s-50s and (b) 2009 (Pye & Blott, 2012)

A desirable minimum target of 10- 15%?

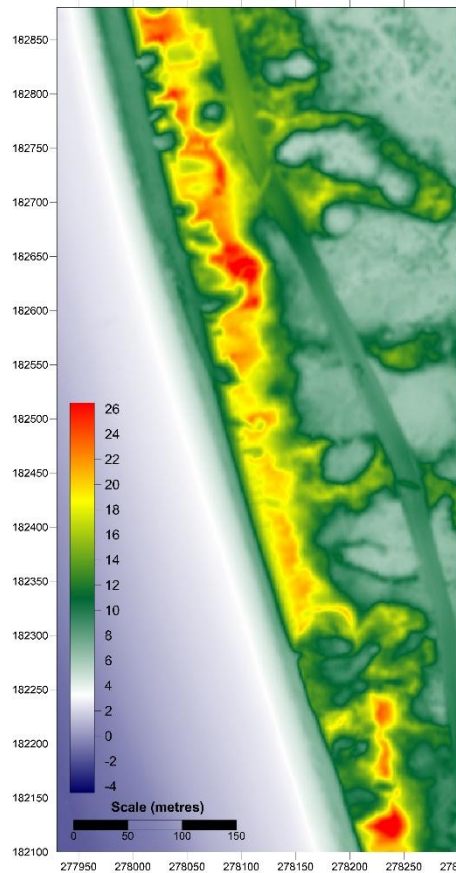
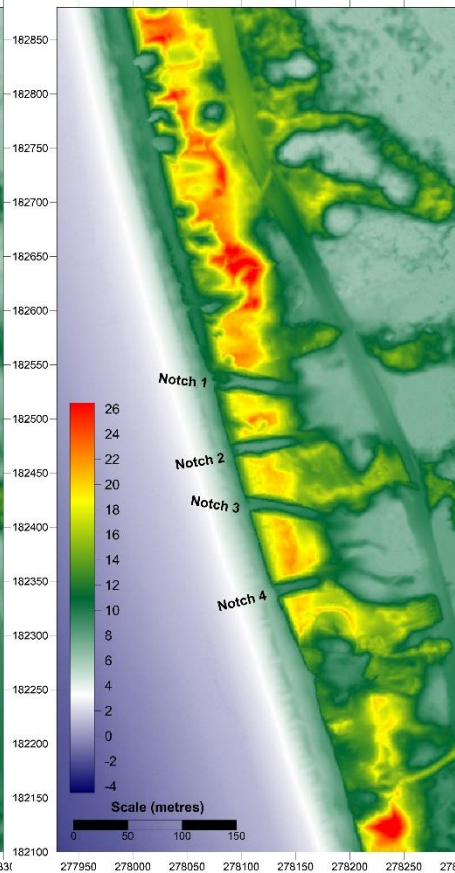
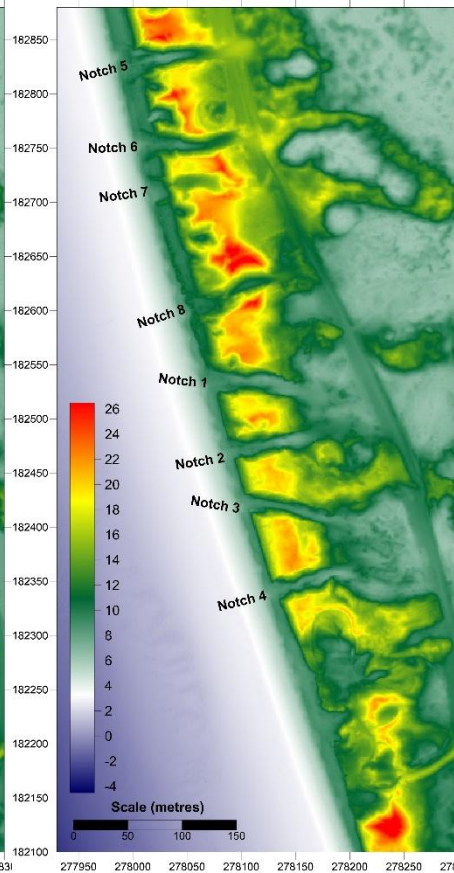
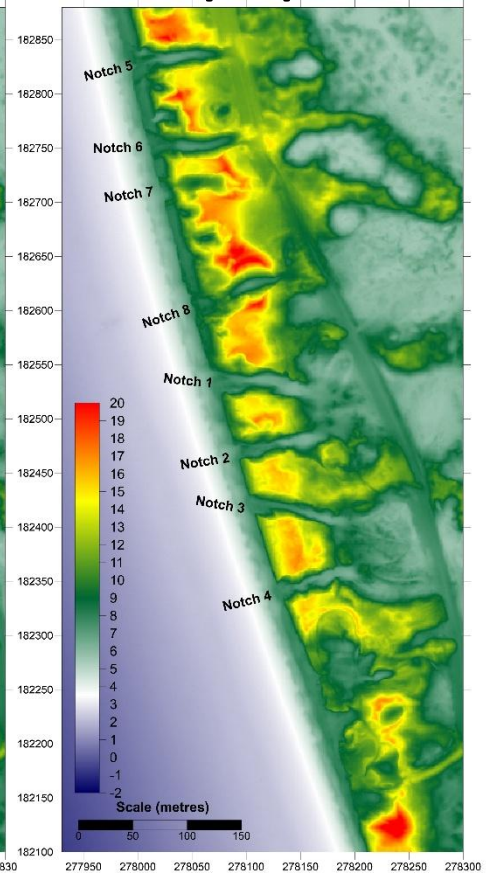
LiDAR Surveys of Phases 1 – 3 at Kenfig 2009-2022

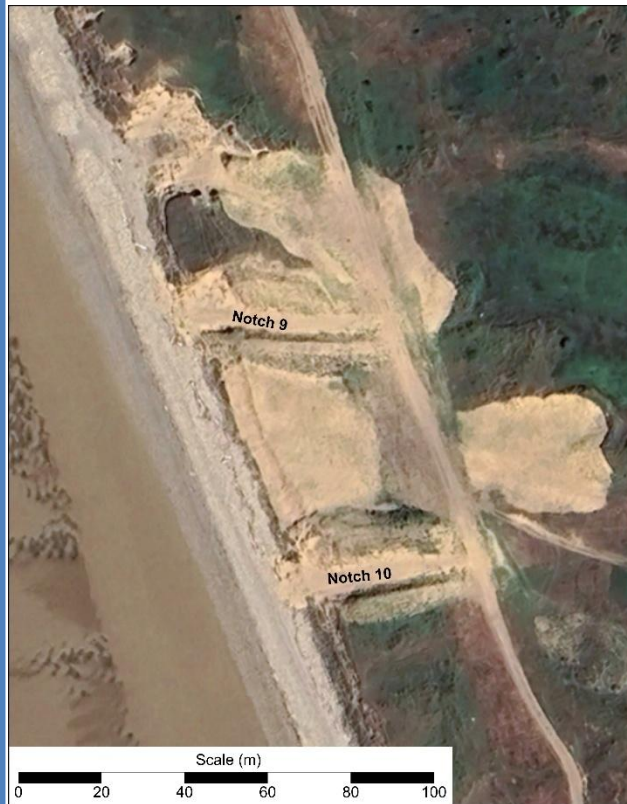
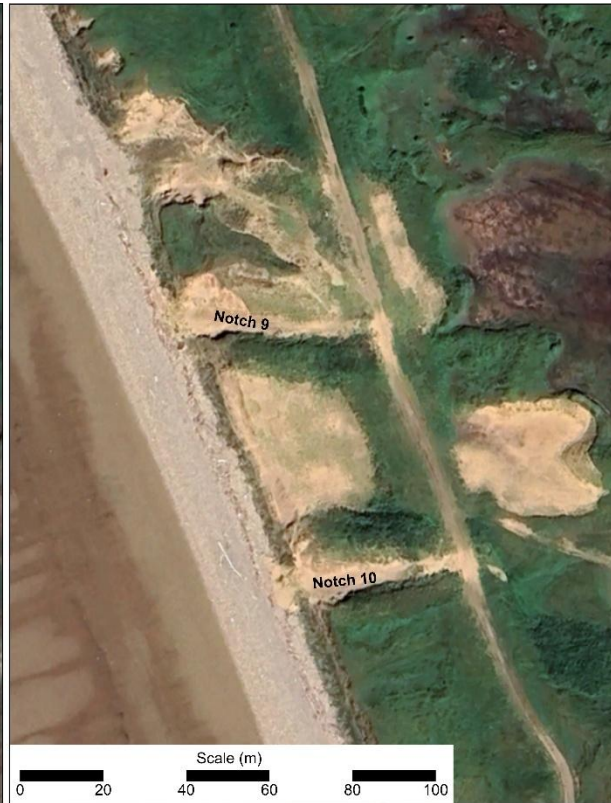
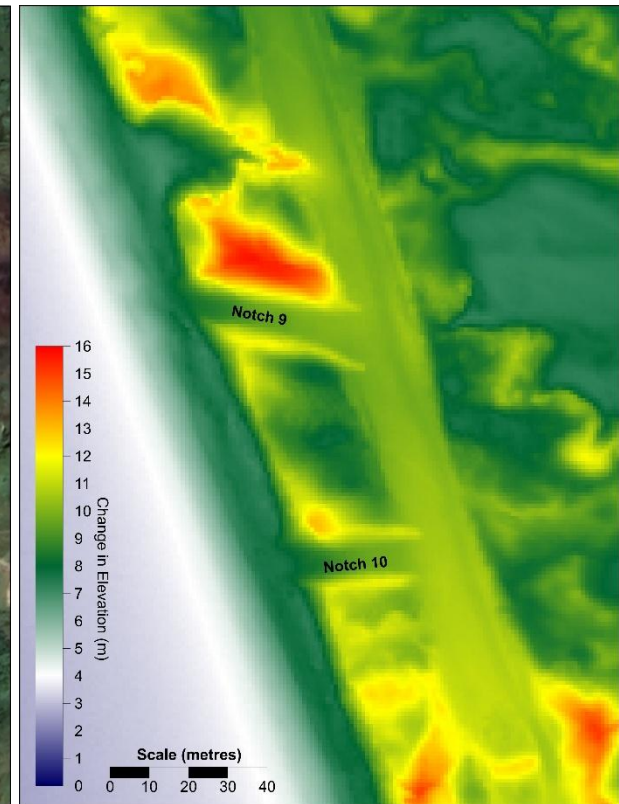
'Notching' and turf stripping at Kenfig Burrows in 2022-23

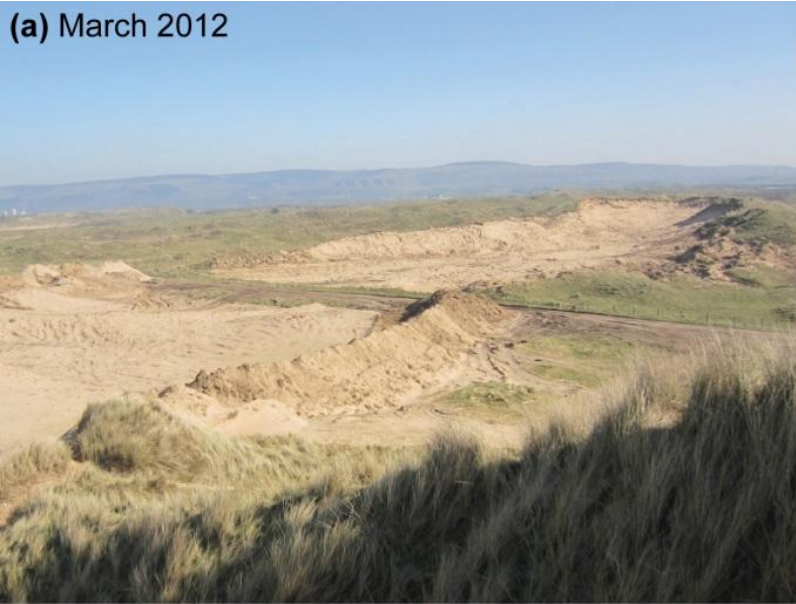
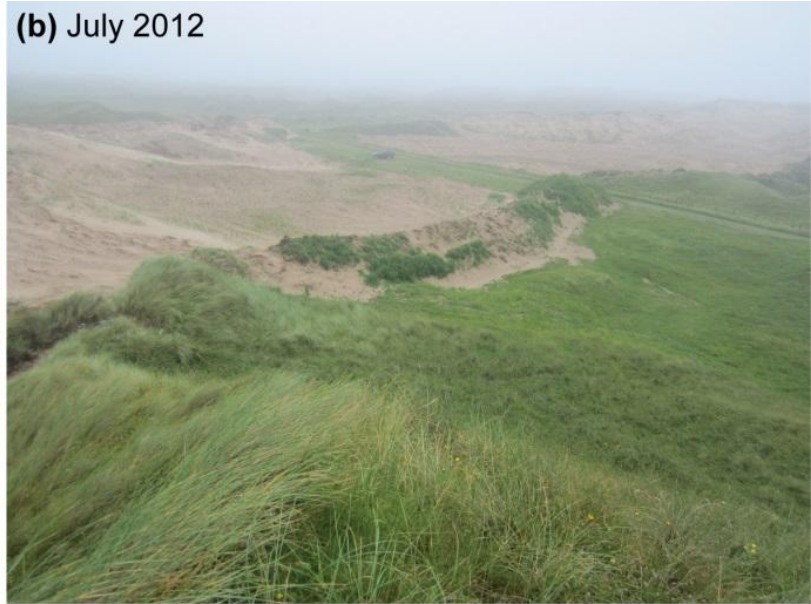
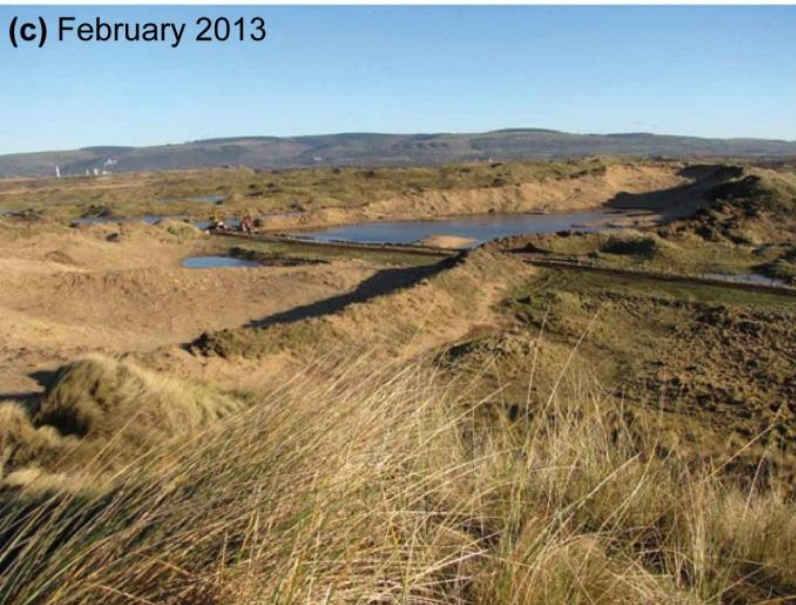
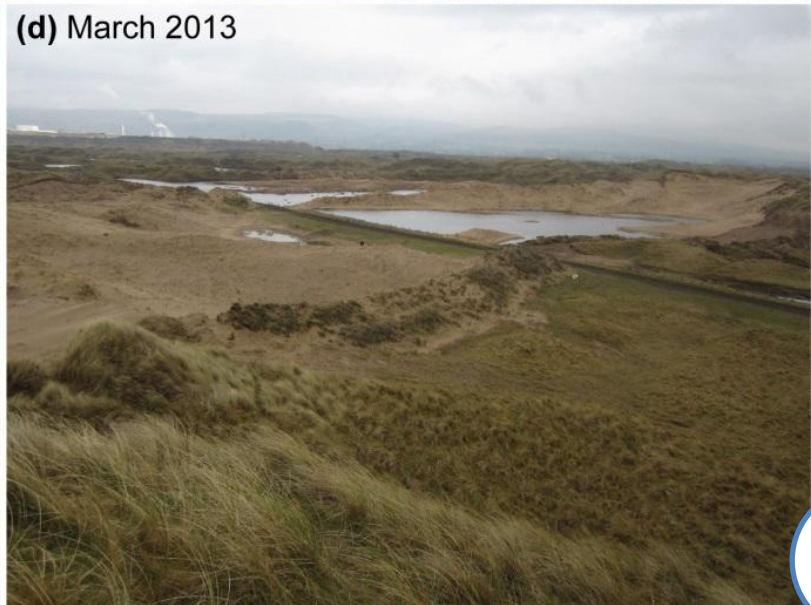
Photographs of Kenfig Phase 1, undertaken winter 2011-2012

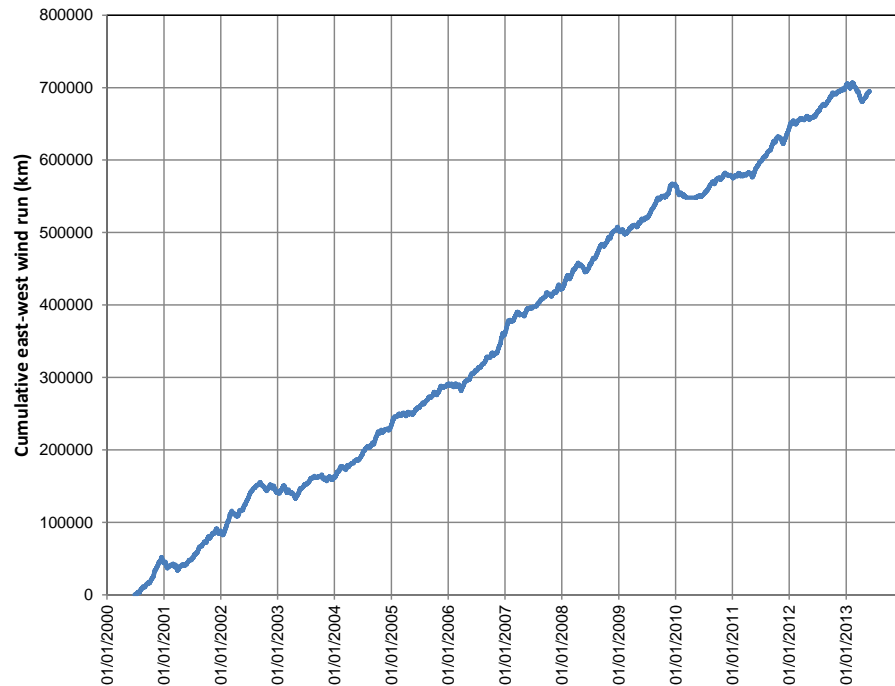
Cumulative wind run and monthly rainfall at Mumbles, 2000-2013

**Cumulative wind run,
2000-2013**

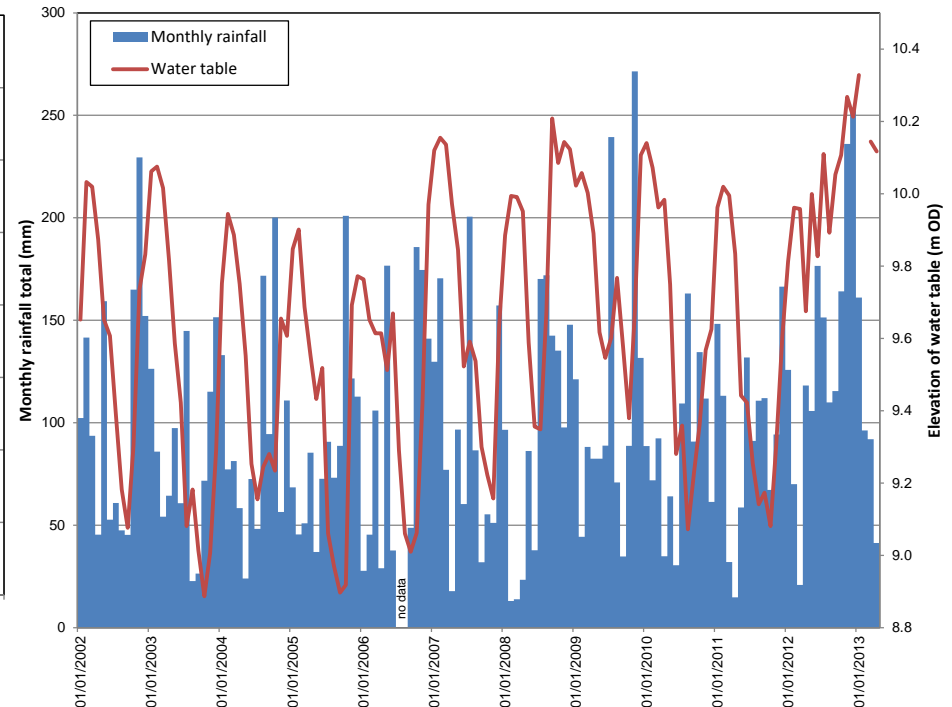
Monthly rainfall 2002-2013

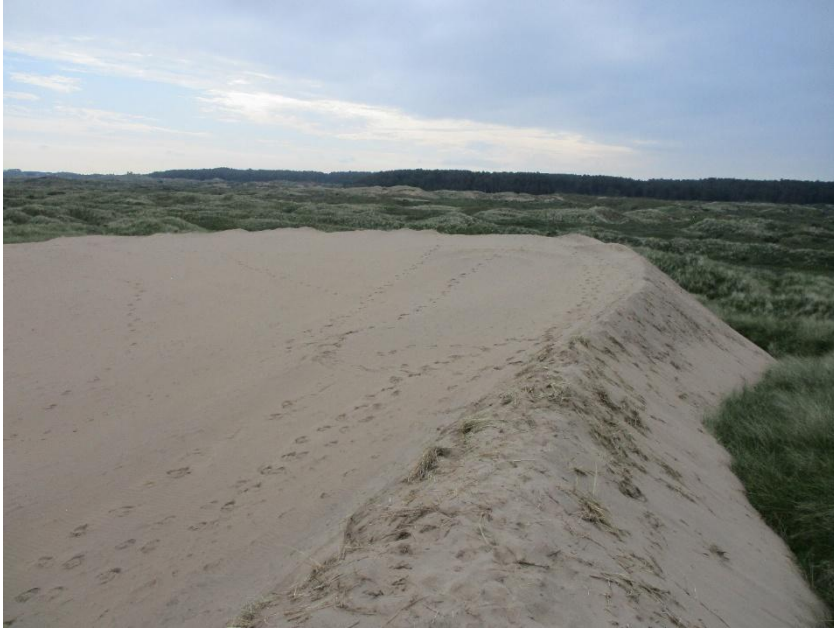
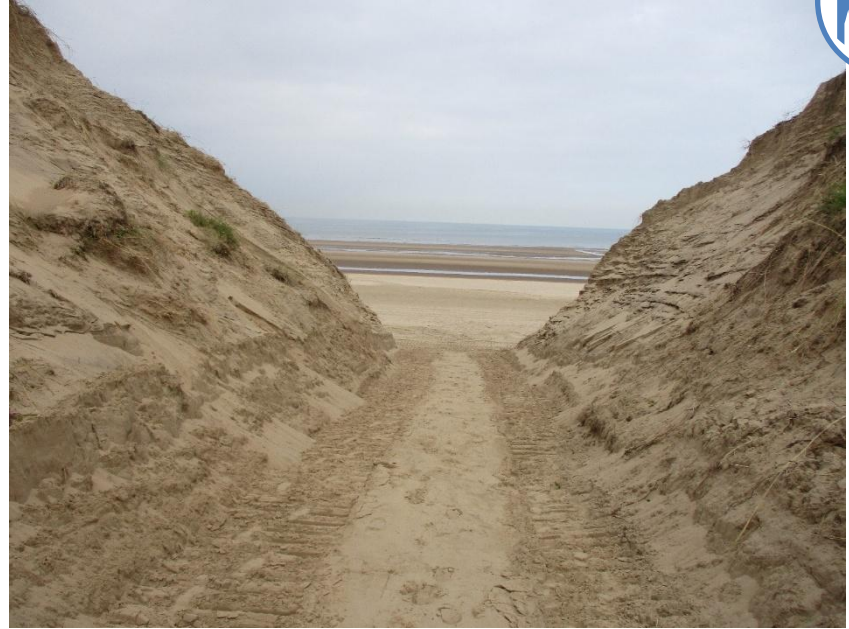
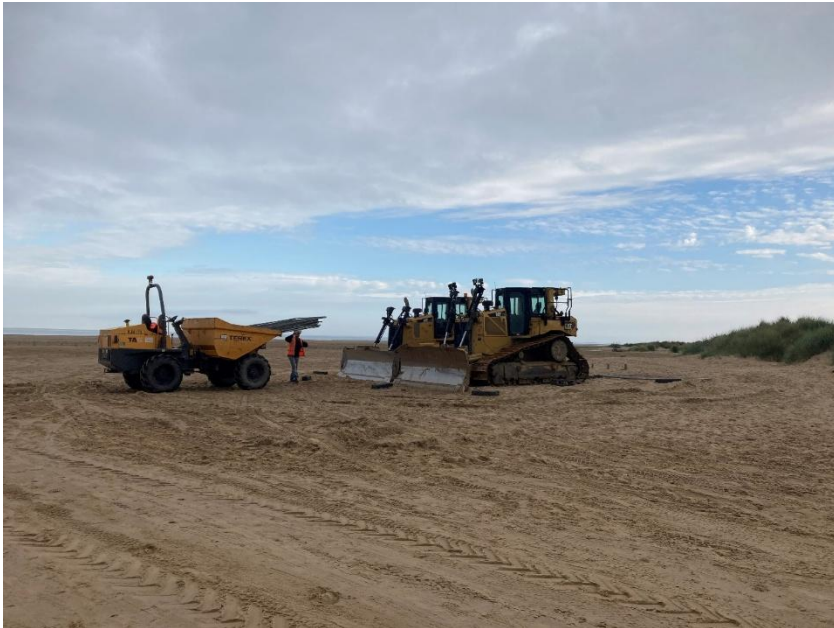
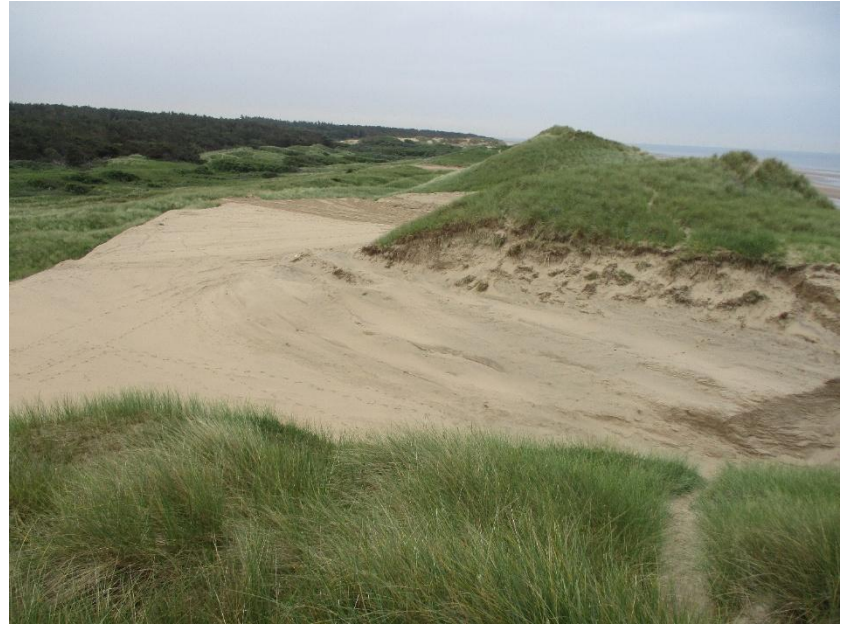
Notching at Ainsdale, taken 2022

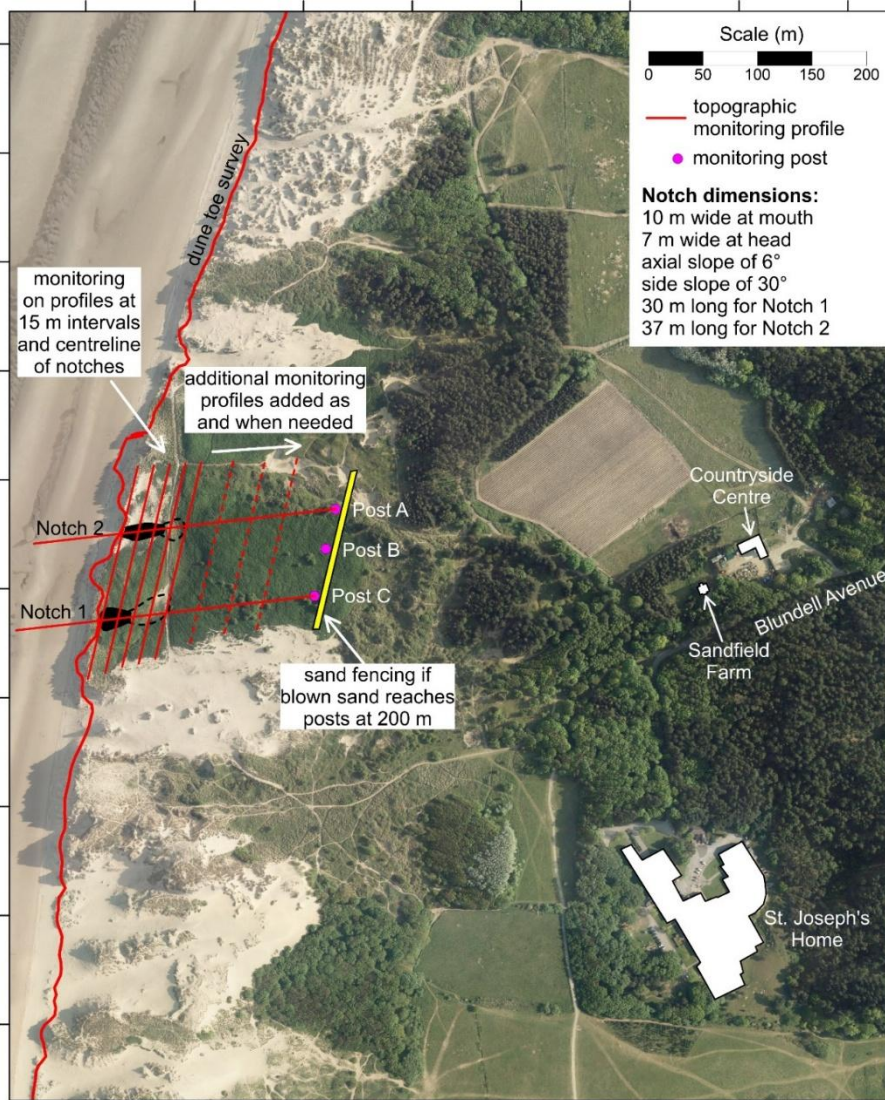
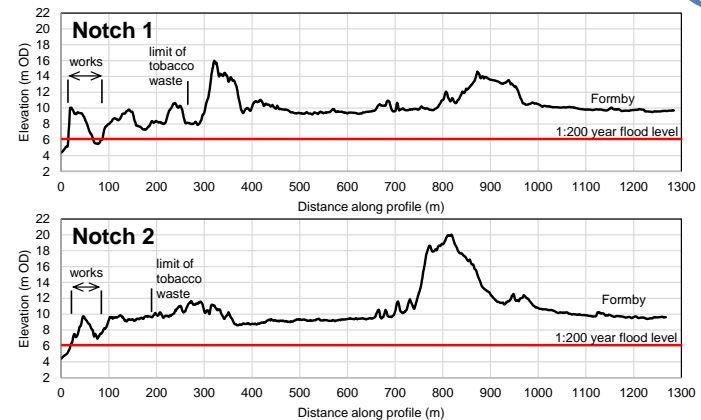
Formby Tobacco Waste Notching – Proposed Monitoring Plan

Identified Risk	Mitigation Measures	Monitoring	Intervention Trigger	Intervention Measures
Coastal erosion	Notches excavated above 1:200 flood level, maximum width at 'mouth' limited to 10 m, spaced 80 m apart with intervening and bordering tobacco waste cliffs acting to maintain erosion rate at current rate	Annual RTK GNSS surveys of the dune toe to assess any change in the long term rate of coastal erosion; upper beach levels and the width and cross-sectional area of each notch to be monitored annually	Recession rate of the dune toe exceeds 2.26 m per year (2005-2019 historical rate plus two standard errors), averaged over a 3 yr period	Erection of sand fencing at the mouth of the notches to limit further wind erosion and movement of beach sand inland through the notches
Coastal flooding	Notches excavated above the extreme 1:200 year flood level of 6.1 m, with sand deposited immediately behind the notch to fill depressions behind	Annual topographic surveys along fixed profiles along and perpendicular to the axes of the notches	Elevation drops below the extreme flood level of 6.1 m OD	Re-profiling of sand to fill low areas using sand deposited from the excavation of the notches

Windblown sand migration onto adjacent property / infrastructure	Notches designed to be narrow (7 m wide at the head) and sloping upwards to limit the amount of sand transported from the beach. Natural high ground 300 m inland (above 12 m ODN) and woodland will prevent sand migrating further than 300 m inland for at least 50 years	Periodic (at least annual) measurement of the landward limit of blown sand relative to 3 fixed posts to be installed 200 m inland of the present cliff edge. Additional annual topographic surveying along fixed profiles along and perpendicular to the axes of the notches. Examination of available aerial photography and LiDAR data at yearly intervals	If significant amounts of blown sand extent within 10 m of the three marker posts, located 200 m inland of the present cliff edge, the requirement for possible intervention measures will be assessed.	Erection of a line of sand fencing behind the marker posts to limit further spread of sand inland. Possible erection of further sand fences across the notches or intervening sand sheets. Possible placement of brushwood and marram planting to stabilize the surface.
